Report card: Straight 'A's

NHGC, which began commercial operation in fall 2004, has three 501G-powered 1 × 1 combined cycles with a total capability of 1092 MW. It is owned by MachGen Holdings LLC, managed by Competitive Power Ventures, and operated by NAES Corp. The merchant plant’s “run season” typically extends from mid June through mid October.

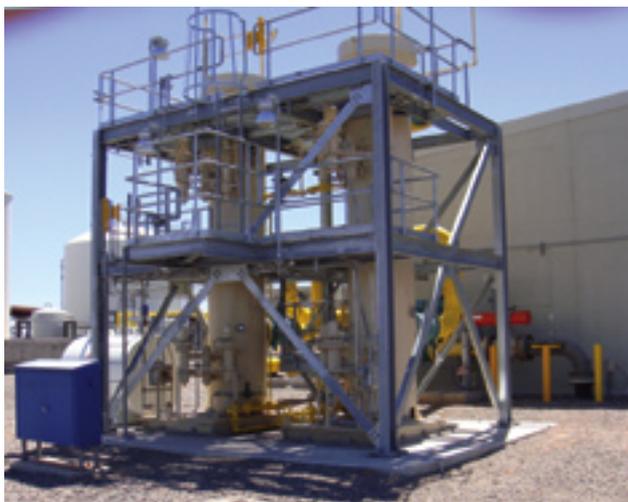
The gas receiving station shown in Fig 1 consists of two 100% coalescing filter towers. They were installed two years ago after a hydrocarbon slug

1. Coalescing filters protect against gas liquids (left)
2. Component barcodes link to work management program (below)

did some damage. The gas supplier created the slug during pigging and maintenance operations. The plant is connected to the main line with a single radial tie.

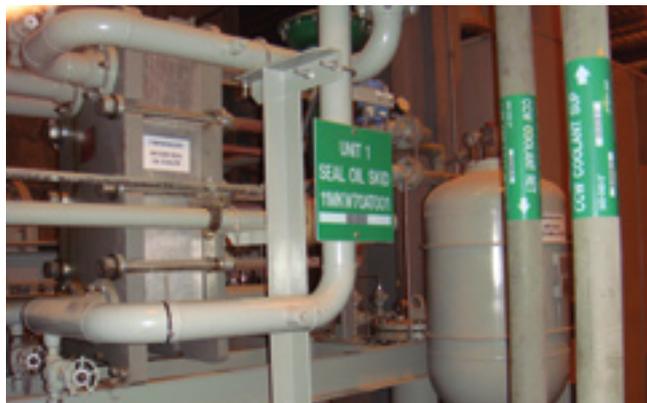
Another project was to label and barcode all pipes and components (Fig 2). A barcode scan links to the work management program and other documentation that provides relevant information for maintenance, repair, replacement, operation, etc.

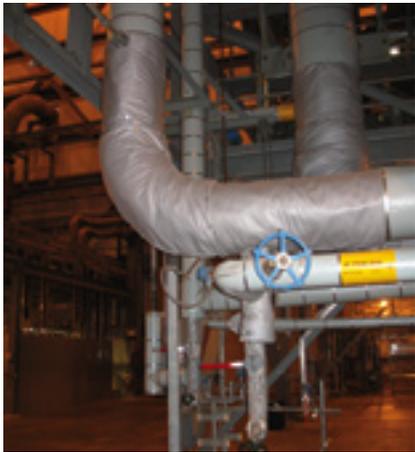
3. Removable insulation facilitates P91 hardness surveys

NHGC has been cited often for its P91 condition assessment program (“P91 commands respect,” 2Q/2010). To facilitate future inspections for trending material degradation, soft insulation covers were installed in critical areas for rapid access (Fig 3).

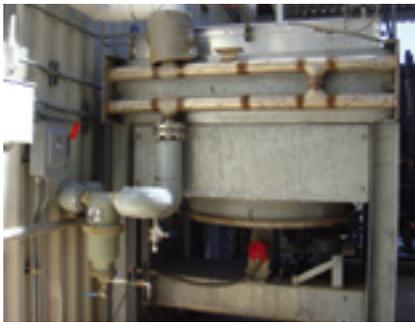
4. Fin-fan cooler allows use of GT compressor air for plant use

Plant and instrument air are taken from the compressor shells of operating units. Air flows via the kettle boilers (rotor air cooler, RAC) to a fin-fan cooler/pressure regulator/water separator. The unit shown in Fig 4 serves the entire plant. Unreliability of plant air compressors forced this design modification. They tripped frequently in summer, resulting in unreliable air availability. The alternative, a standby diesel-powered compressor, cost \$10,000 per month to rent (plus fuel). The original air compressors are used in cooler weather when the plant is not in service.

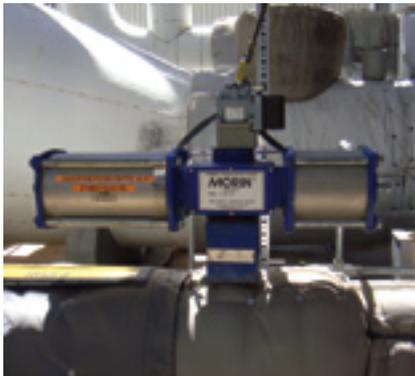
5. Plant valve mods eliminated shaft/bushing binding and resultant automatic unloads

Certain operating conditions call for air to be bypassed around the kettle boiler. Unfortunately, the bypass valve was prone to sticking in the closed position (Fig 5). Plant personnel traced the problem to materials incompatibility at the temperatures experienced. Solution was to change the bushing material to Stellite from Type 316 stainless steel; the shaft to Type 422 stainless from Type 316.

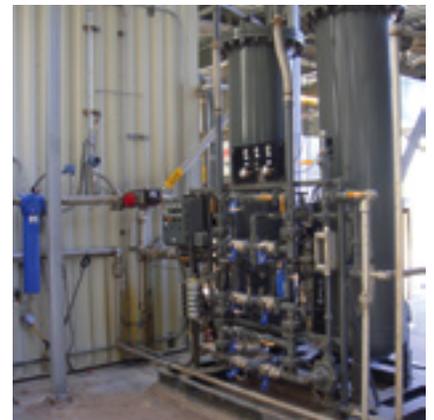
While the economics of onsite hydrogen production was not a slam dunk, onsite production of nitrogen is. The 600-scfm Parker nitrogen generator shown in Fig 6 paid for itself in about 18 months because of the large volume of gas required during layup (three G-class triple-pressure HRSGs, kettle boilers, and welding purge gas).

6. Long periods of layup make onsite nitrogen production cost-effective

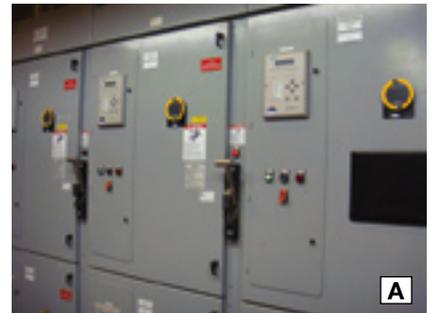
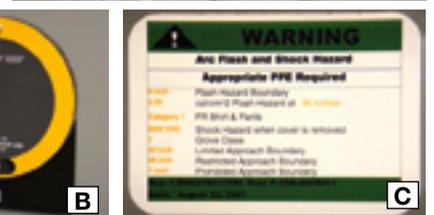
Protection of personnel against arc flash was a major safety initiative at NHGC. Fig 7 shows the infrared windows used to allow thermographic monitoring of

medium-voltage switchgear without opening panels. Clear, concise instructions also are mounted right on the panels.

7. Arc-flash safety practices for medium-voltage switchgear (A) include use of infrared windows for thermography surveys (B) and clear instructions to protect personnel (C)
